Vol. 2/2024 DOI: 10.5507/tots.2024.006

Evaluation of Shared Space Feasibility Based on Traffic-Engineering Data

ROMAN DOSTÁL, ANETA DOSTÁLOVÁ, DAVID HUDEC, JOSEF KOCOUREK

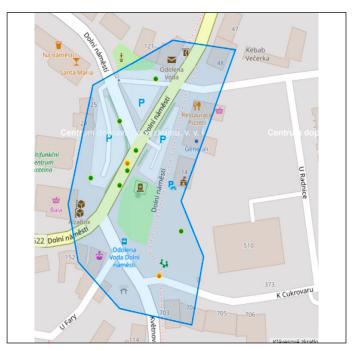
Data on the number of traffic accidents were obtained from the web application 'Accident Locations' - https://nehody. <u>cdv.cz</u>. Over the last ten years, 9 traffic accidents have been reported in the area under study. These included 7 accidents with material damage and 2 with minor injuries. Six of the accidents involved a collision with a moving non-rail vehicle. Two involved collisions with pedestrians, and one involved a collision with a parked or stationary vehicle. Both incidents resulting in minor injuries involved pedestrians, who presumably crossed the roadway in locations lacking official pedestrian crosswalks. These crossing points, while not formally designated, appear to align more closely with intuitive and direct pedestrian routes, as opposed to the existing, planned pedestrian infrastructure. This observation suggests a discrepancy between the naturally preferred pedestrian pathways and the currently implemented urban design.

Further analysis of these incidents reveals a pattern of accidents predominantly involving moving vehicles, highlighting potential safety concerns for non-rail vehicle traffic. The frequency of accidents with pedestrians also underscores the need for improved pedestrian safety measures in this area. The data suggests that while the number of accidents is relatively low, the nature of these incidents calls for targeted interven-

tions to enhance road safety, particularly in terms of vehicle speed regulation and pedestrian crossing safety. Each of the accidents is depicted in the image below (Figure 6).

Figure 6: Accident Analysis Situation at Dolní Náměstí in Odolená Voda (Police of the Czech Republic, 2023).

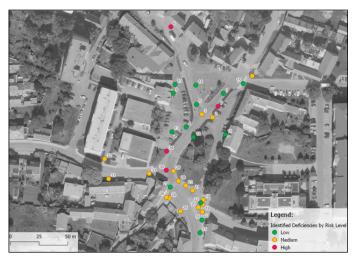
A safety inspection at Dolní Náměstí in Odolená Voda identified critical traffic safety issues. The inspection revealed that straight road sections lacked features to engage driver attention in areas frequented by vulnerable road users, warranting complex solutions despite being low risk. High-risk areas included busy intersections and inadequately designed exits from parking areas, with the Úžická - Velkoveská intersection posing additional cyclist visibility risks.

Road conditions, characterized by worn surfaces and sharp curb edges, raised concerns for vehicle control, necessitating both complex and moderate remedial measures. Similarly, parking zones, especially bus lay-bys, were poorly designed, creating hazardous conditions that require comprehensive solutions. Inconsistencies in traffic signage at intersections and inadequate pedestrian crossing lighting were also identified, both needing complex interventions.

A notable issue was the lack of sidewalks and pedestrianfriendly infrastructure, leading to unregulated pedestrian movement and heightened risks. This was compounded by insufficient infrastructure for cyclists and narrow sidewalks in Dolní Náměstí, emphasizing the need for holistic solutions. Additional concerns included low flowerpots creating visibility issues for larger vehicles and overly long pedestrian crossings at Pod Tvrzí Street lacking clear guidance.

In total, 34 traffic and safety risks were identified during the inspection. The proposed measures to address these risks varied in complexity, with the objective of enhancing traffic safety to an acceptable level in Odolená Voda. Figure 7 illustrates the key locations of these traffic and safety deficits.

Figure 7: Overview of all identified traffic safety risks at Dolní Náměstí in Odolená Voda.

The safety inspection at Dolní Náměstí in Odolená Voda highlighted key deficiencies in intersection layouts, road surfaces, and pedestrian infrastructure. Recommended corrective measures include:

Overhauling traffic signage, replacing confusing signs, and updating horizontal markings for clarity and safety. Adjusting routes to accommodate visually impaired and mobilityrestricted individuals, aligning with Regulation No. 398/2009 Coll., to enhance accessibility and safety.

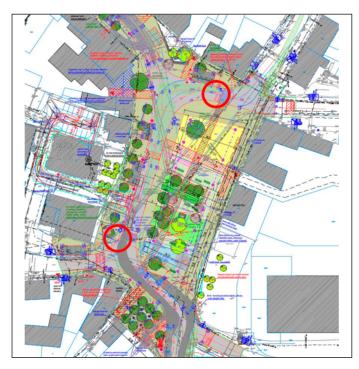
Significant findings from the audit include substantial reductions in parking spaces proposed by the project, which could adversely affect the surrounding area of Dolní Náměstí. The new parking design presented several deficiencies and risks, notably the lack of clear signage and surface treatment for the descent into the parking area, potentially leading to dangerous situations (Figure 8).

Figure 8: Evaluated Proposed Documentation of the Square in Odolená Voda by company KT ING s.r.o.

The road safety audit for Dolní Náměstí's extensive reconstruction plan revealed significant shortcomings. The project documentation lacks crucial information on directional

alignment, vertical profiling (elevation), and roadway widths, impeding the assessment of vital aspects like road drainage and sidewalk accessibility.

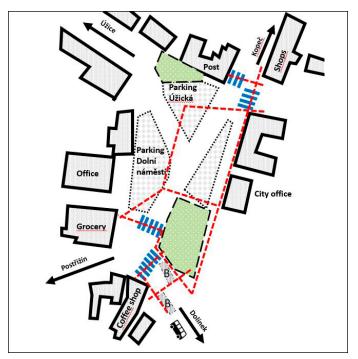
Figure 14: Scheme of recorded trajectories of pedestrians on the measured day of 2. 8. 2023 (depicted by red dotted lines).

An examination of pedestrian spatial utilization reveals a predominant adherence to designated pedestrian pathways and crosswalks. However, a discernible number of trajectories deviating from these predefined paths were recorded, as delineated in the figure below. Such trajectories underscore a predisposition among pedestrians towards a more liberal utilization of the square's spatial expanse, beyond the confines of designated crosswalks (Figure 14).

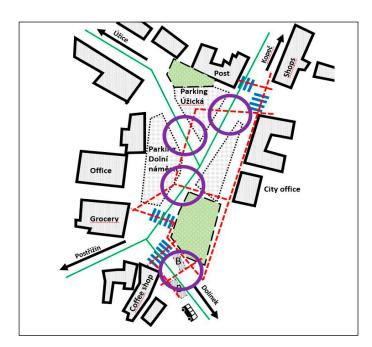
Detailed trajectory analysis was conducted, documenting a total of 9,336 movements. This analysis was crucial in identifying key trends and patterns. Among these, pedestrians accounted for 2,364 distinct movements, highlighting their significant presence in the square. This high number of pedestrian movements emphasizes the need for careful consideration of pedestrian needs in urban planning, particularly in shared spaces where their safety and comfort are paramount (Figure 18).

Figure 18: Diagram of the most frequent expected collision points (purple circles) determined based on the examined trajectories of pedestrians (red dashed curve) and personal cars, public transport vehicles, and vans (green solid curve) on Wednesday, August 2, 2023.

The survey revealed frequent collision points involving pedestrians, public transport vehicles, personal cars, and vans, which are vital for assessing the capacity for a shared space. The analysis of these trajectories and collision points, illustrated in the accompanying figures, provides a clear picture of the complex interplay of different road users within Dolní Náměstí.
